Dry drilling of alloy Ti–6Al–4V

J.L. Cantero^{a,*}, M.M. Tardío^b, J.A. Canteli^a, M. Marcos^c, M.H. Miguélez^a

This work is focused on the combined study of the evolution of tool wear, quality of machined holes and surface integrity of work-piece, in the dry drilling of alloy Ti–6Al–4V. Tool wear was studied with optical microscope and SEM–EDS techniques. The quality of machined holes was estimated in terms of geometrical accuracy and burr formation. Surface integrity involves the study of surface roughness, metallurgical alterations and microhardness tests. The end of tool life was reached because of catastrophic failure of the drill, but no significant progressive wear in cutting zone was observed previously. High hole quality was observed even near tool catastrophic failure, evaluated from the point of view of dimensions, surface roughness and burr height. However, microhardness measurements and SEM–EDS analysis of work-piece showed important microstructural changes related with a loss of mechanical properties. Depending on the application of the machined component, the state of the work-piece could be more restrictive than the tool wear, and the end of tool life should be es

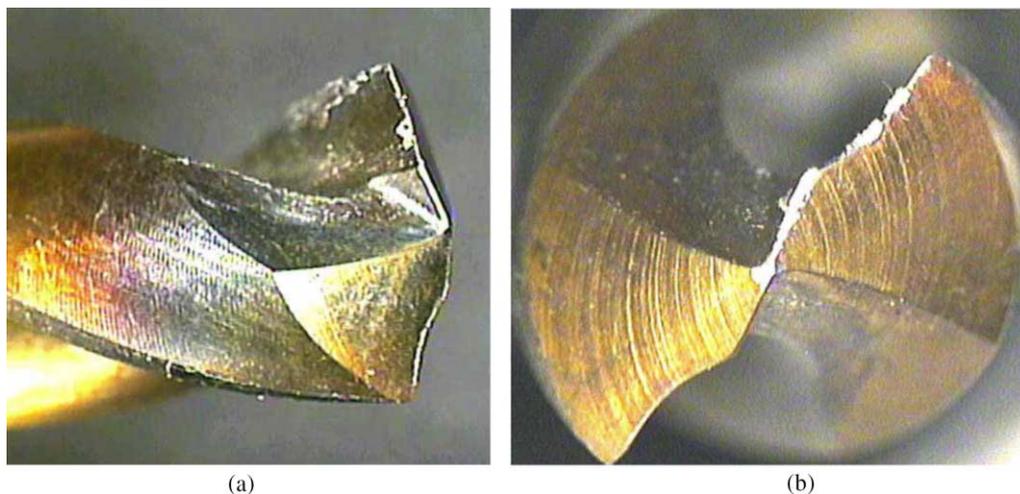
Fig. 1. Optical microscope photographs of drill II after the first series of eight holes (condition II, cutting time 0.4 min): (a) side view of the drill, and (b) end view of drill showing material adhesion.

Fig. 1(a) and (b), are photographs (obtained in an optical microscope) of drill II after the first series of eight holes (condition II, cutting time 0.4 min). Images show material adhesion in the clearance surface of the tool (specially in cutting edge corners and drill point). However, drill geometry did not present significant changes.

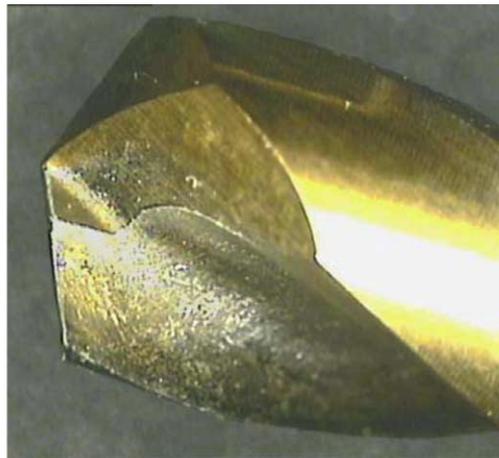
Drill I presented slower wear evolution. Fig. 2(a), shows drill I after machining eight holes (condition I, cutting time 0.4 min). A smaller amount of material work-piece is adhered to the same zones that in the former case (drill point and clearance surface). No significant changes (flank wear, rounding of cutting edge, etc.) are observed in drill geometry.

Fig. 2. Initial wear of drill I: (a) optical microscope view of drill I after machining eight holes (condition I, cutting time 0.4 min), and (b) SEM micrograph of rake face of drill I after machining 15 holes (condition I, cutting time 0.8 min).

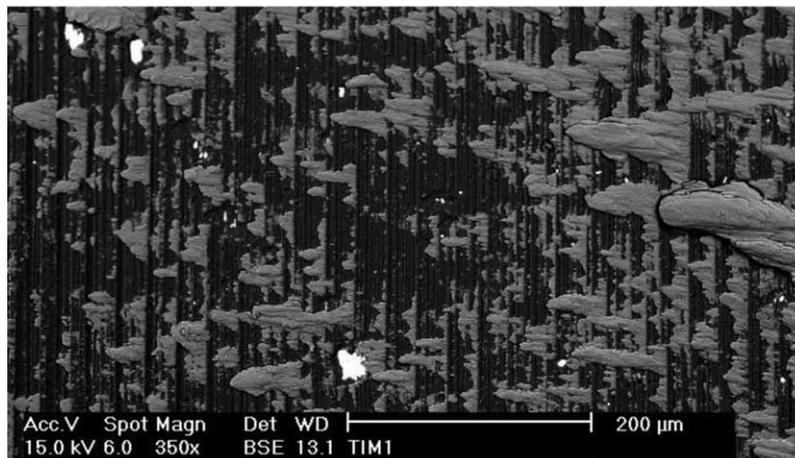
(b)

Drill I and II surfaces were analysed with SEM–EDS technique. Fig. 2(b) shows SEM image of rake surface of drill I, after machining 15 holes (cutting time 0.8 min). Zones with different contrast were analysed with EDS technique. Black zone corresponds to the tool coating (TiN), grey zone is material work-piece adhered to the tool and white zone corresponds to tool substrate (22% Co–78% W), due to loss of coating.

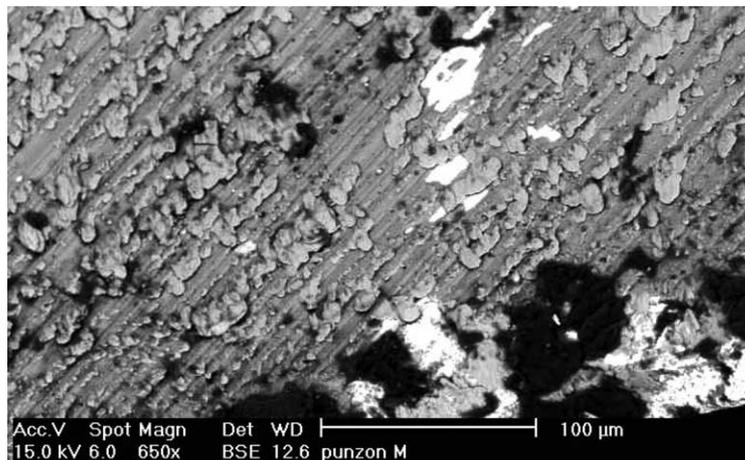
Fig. 3(a) shows a SEM image of drill II after machining 64 holes (eight series of eight holes, cutting time 3.4 min, being this time approximately half of tool life in this condition). In the EDS analyses of the chemical

composition, darker zone corresponds with residue with elevated content of C, light grey is Ti alloy adhered on the tool, dark grey corresponds to tool coating (TiN) and white zone is tool substrate without coating. It is observed a notable increase of work-piece material adhesion and loss of coating in the tool, when compared with initial stage of wear. However, it should be noted that most of TiN coating remains in the drill, being a protective layer against tool wear [7,19].

Fig. 3. Medium wear of drill I and drill II: (a) SEM micrograph of rake face of drill II after eight series of eight holes (condition II, cutting time 3.4 min), (b) optical microscope end view of drill I after machining 250 holes (condition I, cutting time 13.4 min).

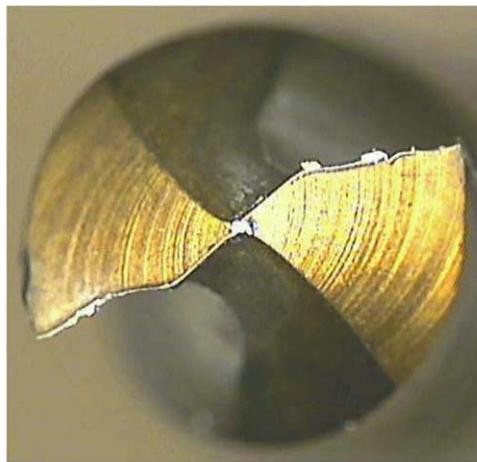
(b)

Fig. 3(b) shows an optical image of drill I after machining 250 holes (condition I, cutting time 13.4 min, being this time approximately half of tool life in this condition). Cutting edges showed a good state of geometry. However, craters in the helical flute of the drill can be observed. Fig. 4 is a photograph of the drill I after machining 80 holes (cutting time 4.3 min). The same mechanism of wear was observed in drill II. As the number of holes machined increased, the size and the amount of craters increased. This tendency was more pronounced in drill I, taking up a surface of 3 mm in the direction of the helix and 1 mm wide. Although the craters do not affect

the cutting edge geometry, (and apparently, do not affect cutting process), they weaken the tool [20].

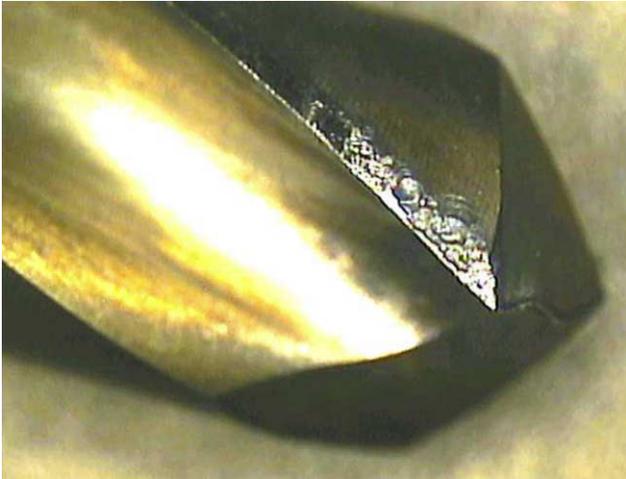
Fig. 4. Optical microscope view of drill I after machining 80 holes (condition I, cutting time 4.3 min) showing craters in the helical flute.

Craters are located in a tool zone that reach high temperatures and suffers severe friction during machining. Posterior analysis of the composition of this zone revealed diffusion of work-piece material. The intimate contact between the titanium chip/work-piece and the tool at temperatures above 900 °C provide an ideal environment for diffusion of material atoms across the tool/chip or tool/work-piece interface. The combined action of diffusion and attrition originates the craters.

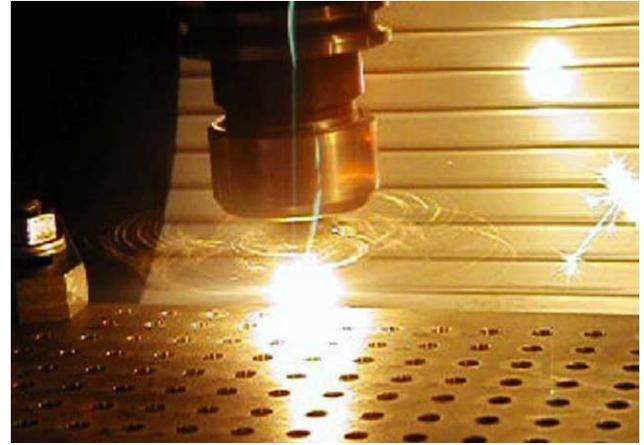
Cutting edge geometry does not change significantly up to the end of life of the tool. However, as cutting time increased, heat generated in the process increased, due to loss of coating, adhesion of work-piece material and small defects originated at the cutting edge. Tests were carried out in absence of cutting fluid, so high temperature is reached and combustion of chip was observed in some cases. In condition II, small sparks due to weak combustion of the chip appeared after the first series. This tendency increased as the number of holes increased. Since 10th series (cutting time 4 min) the chip began to burn, and since 14th series (cutting time 6 min) chip burned in a more intense way (see Fig. 5). During machining in condition I sparks appeared later (after 70th hole, cutting time 3.8 min). Complete combustion of the chip was observed firstly in hole number 395 (cutting time 21.2 min).

Fig. 5. Drilling test with combustion of the chip corresponding to 14th series with drill II (cutting time 6 min).

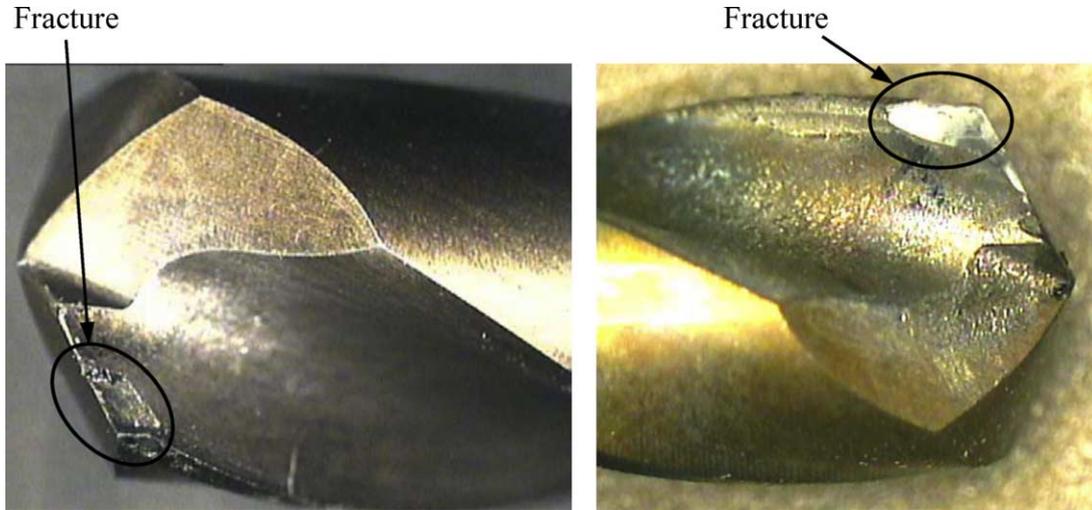
Drill I broke in the corner of one of its cutting edges (this is the zone of the tool that reaches maximum temperature during cutting). However, the rest of the cutting edge and the other edge, do not show significant changes in geometry. Drill failure indicated end of tool life and happened after 455 holes (cutting time 24.5 min, see Fig. 6(a)). Drill II broke after 16 series of eight holes (cutting time 6.9 min).

Fig. 6(b) show fracture in drill II located in the corner of one of its cutting edge and extended towards helical flute. This was the zone where diffusion of work-piece material and elevated number of craters weakened the drill.

Fig. 6. Optical microscope photographs of catastrophic failure of drill I and drill II: (a) broken drill I after machining 455 holes (condition I, cutting time 24.5 min), and (b) broken drill II after 16th series with drill II (condition II, cutting time 6.9 min).

High stress and severe cutting temperatures coupled with the brittleness of the substrate tool due to diffusion, may accelerate the chipping, flaking, cracking, and fracture of the tool [7,14]. Catastrophic failure of the tool occurs without previous significant progressive tool wear.

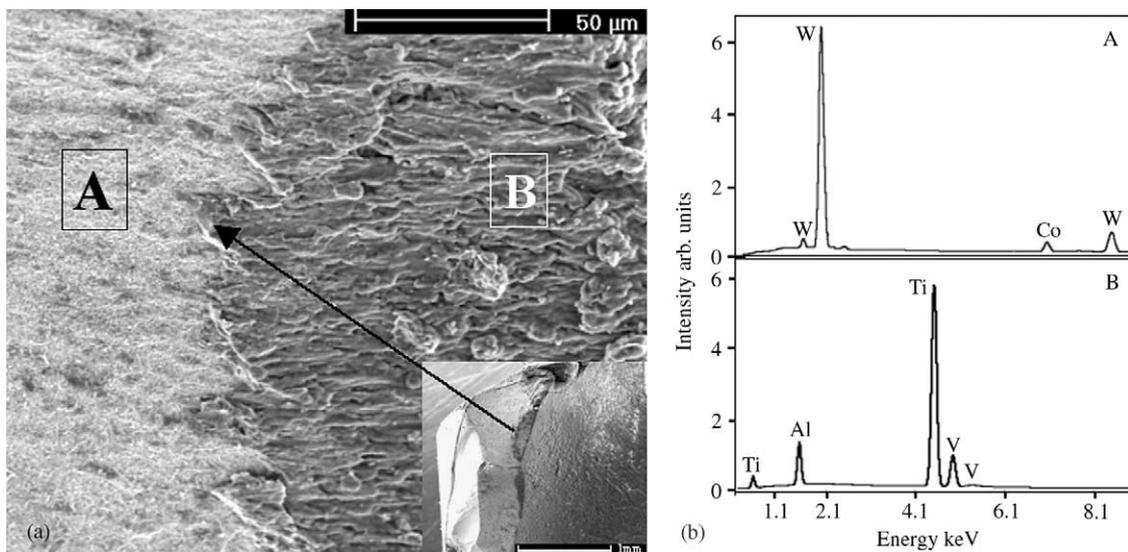
Fig. 7(a) is an electronic microscope image of the drill II after 128 holes (end of tool life), showing diffusion of material work-piece (dark zone of the image) due to high temperature reached in this zone and the loss of TiN coating. Analysis EDS (Fig. 7(b)) showed chemical composition of light (A) and dark (B) zone. Spectrum A presents peaks of W and Co, corresponding to drill substrate, however, peaks distribution of spectrum B are similar to those corresponding to composition of work-piece material.

SEM-EDS analysis showed diffusion in helical flute of drill. In addition craters due to adhesion and attrition were observed in this zone. The absence of craters in rake surface may be explained because of the tendency of WC/Co grades of cemented carbide to react with the work-piece to form a TiC layer. According to Hartung and Kramer [21] the presence of this layer eliminates the sliding between chip and tool, thus maximising the crater wear resistance [22]. The wear will be limited by the diffusion rate of the tool constituents through this layer. This process of wear is believed to occur at a lower rate compared to that caused by physical motion of the chip under sliding conditions [15].

Fig. 7. SEM-EDS analysis of the drill II rake face after 128 holes corresponding to the tool failure: (a) SEM micrograph showing diffusion of material work-piece (dark zone) in the tool. The inset is a close-up of the diffusion region. (b) EDS spectra recorded from regions A (top graph, corresponding to tool substrate) and B (bottom graph, corresponding to work-piece material) in (a).

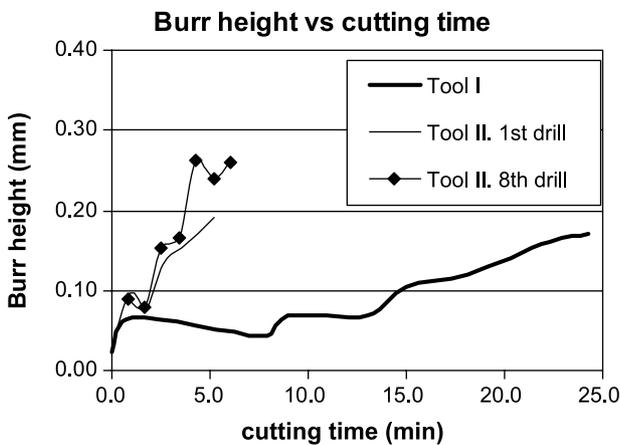
Fig. 8 shows evolution of burr height versus cutting time, corresponding to both conditions I and II (burr height of first and last hole of each series are presented). Burr height increased as cutting time, and so tool wear, increased due to the higher temperatures. Holes machined in condition II (drill II), showed higher burr than those machined with drill I. Burr formation presented more sensibility to heat accumulation than resultant diameter. However, burr height presented moderate values up to tool failure, even in condition II.

Fig. 8. Burr height versus cutting time for condition I and condition II (first and last hole of each series with tool II are presented).

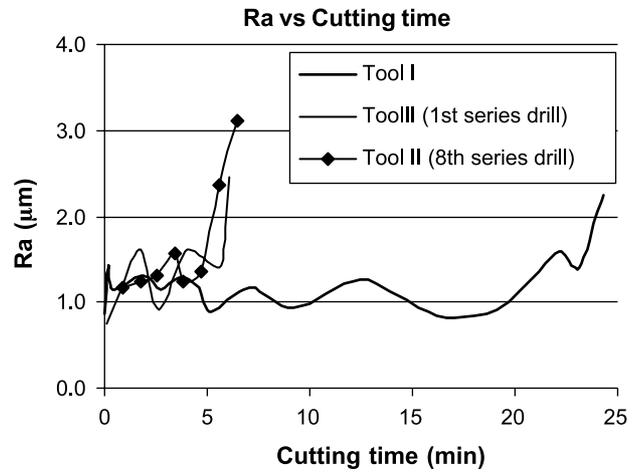
Fig. 9 shows evolution of surface roughness of holes machined with drill I and drill II (roughness of first and last hole of each series are presented) versus cutting time.

In both condition I and II, average roughness (R_a) was approximately 0.7 μm in initial holes. Roughness increased at cutting time corresponding to medium wear of the tool, ranging from 1 to 1.5 μm . Finally, close to tool failure, roughness increased up to 2.5 μm . Roughness values recorded were unstable during the cutting tests (specially in

Fig. 9. Surface roughness versus cutting time for condition I and condition II (first and last hole of each series with tool II are presented).

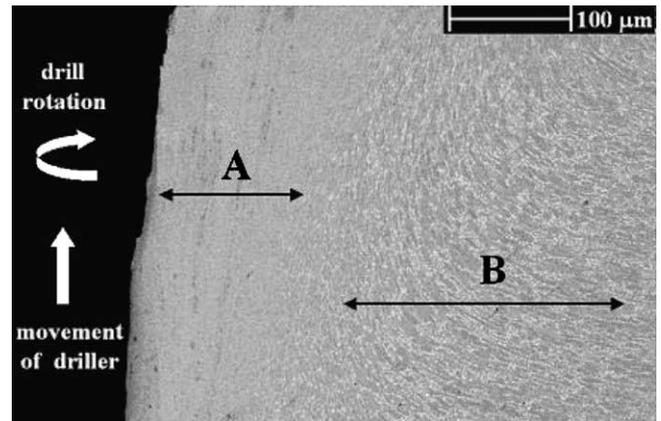
The same qualitative microstructural changes were observed in both condition I and II, but more pronounced in the last condition. Results obtained in condition II are shown in SEM micrograph for a work-piece after 16 series of eight holes (see Fig. 10). The image is a section of a hole

Fig. 10. SEM micrograph of the material work-piece near the surface of the 128th hole machined with drill II. Two regions A and B with different microstructure can be observed: region A, closer to the drill hole surface, with a width of ~125 μm , corresponds to high temperature; region B, with a width of ~200 μm , corresponds to medium temperature. The black area is the drill hole.

containing the revolution axis of the drill. Two regions A and B with different microstructure can be observed.

Region A, closer to the drill hole surface, with a width of $\sim 125 \mu\text{m}$, corresponds to the highest temperature and the most elevated stress. The width of this region is not uniform along the direction of the drill displacement. Variation in width up to $25 \mu\text{m}$, is due to higher temperature at the end of the hole (the wider zone) [27]. SEM–EDS analysis showed the absence of light zones corresponding with phase β (with high V content). When titanium alloys are heated in an oxygen or nitrogen-containing ambient, a surface-hardened zone is formed. This layer is referred to as ‘alpha case’ because oxygen and nitrogen stabilize alpha phase [28]. This is in very good agreement with microhardness observations.

Region B, presents different microstructure because of decrease of temperature with increasing radial distance from the drill hole surface. SEM–EDS analysis allowed to distinguish between two phases, being light zone phase beta and dark zone phase alpha. A strong distortion in microstructure is observed, and the grains are oriented in the direction of the drill displacement. Plastic deformations during machining are caused by mechanical forces from the cutting tool acting upon the work-piece. Additional deformation can occur as a consequence of temperature gradients due to local heating of the machined surface area.

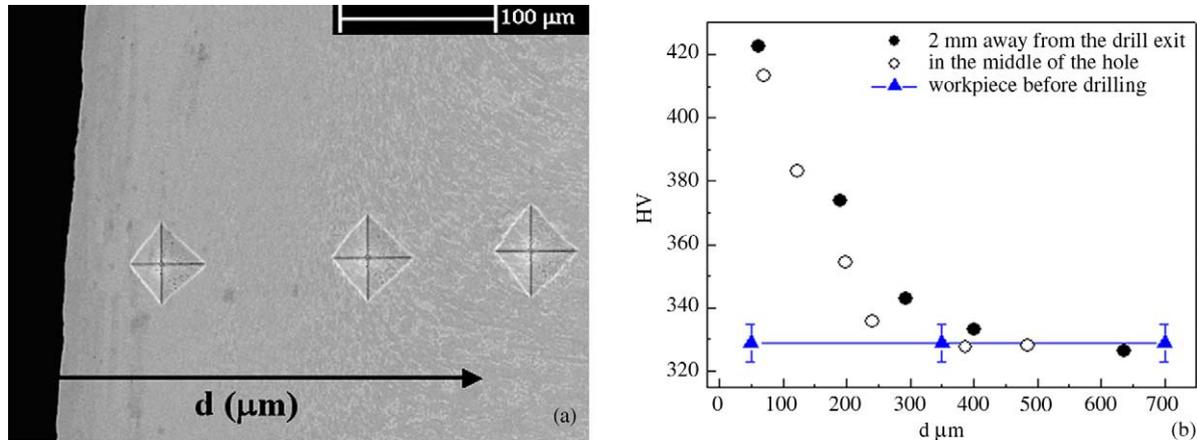
Fig. 11. (a) SEM micrograph showing three microindentation marks on a region approximately 2 mm away from the drill exit, for the 128th hole machined with tool II, (b) contains the microhardness data for two different regions in the same drill hole as (a); black solid circles correspond to the region shown in (a) and open circles to a region close to the middle of the hole; d is the distance measured from the drill hole surface inwards the workpiece; triangles correspond to the microhardness before drilling.

Fig. 11(a) shows marks resulting from microhardness tests in the same specimen obtained from 128th hole machined with drill II. Microhardness (Vickers) was measured in five points (located at a distance d from machined surface ranging from 50 to $600 \mu\text{m}$) in two lines perpendicular to the drill displacement direction. First line was approximately in the middle of plate thickness, 4 mm

away from the exit of the hole, and second line was 2 mm away from the exit of the hole. Microhardness distribution is shown in Fig. 11(b).

In the zone close to machined surface (distance $75 \mu\text{m}$) value of 420 HV was obtained, approximately 30% greater to hardness obtained in material before machining. As distance d to machined surface increases microhardness decreases, reaching values similar to those obtained over material before machining (330 HV) at a distance $500 \mu\text{m}$.
