## Electron microscopy study of SiC obtained by the carbonization of Si(111)

A SiC thin film grown by propane carbonization of a Si(111) substrate has been characterized by transmission electron microscopy and scanning electron microscopy techniques. This study reveals the presence of planar defects in the SiC layer and voids in the Si(111) substrate as well as misfit dislocations at the SiC/Si interface. The resulting SiC layer consists of a mosaic structure and is shown to have low stress. © 1999 Elsevier Science S.A. All rights reserved.

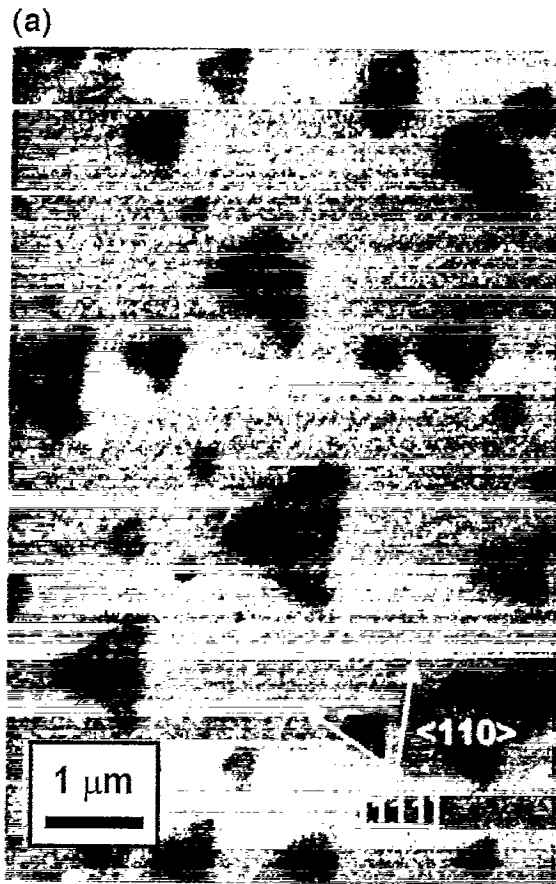
Fig. 4. (a) Scanning electron microscopy image revealing the presence of equilateral triangular and non-regular shape voids and a rough surface. (b) Void side size histogram showing the existence of at least two different distributions.

In agreement with TEM observations, SEM study revealed the presence of voids and a surface roughness. In SEM micrographs as shown in Fig. 4a, equilateral triangular

shape voids with their sides along  $\{110\}$  directions are evidenced as well as non-regular shape voids with smaller sizes. By studying SEM images of the sample surface corresponding to a total area of  $280 \mu\text{m}^2$ , the void size distribution resulted to be as shown in Fig. 4.b. The average void size was  $0.52 \pm 0.27 \mu\text{m}$  and the area fraction in the growth plane occupied by voids resulted to be 9.6% approximately.
